Power Quality Case Study – Electronic Component Distributor

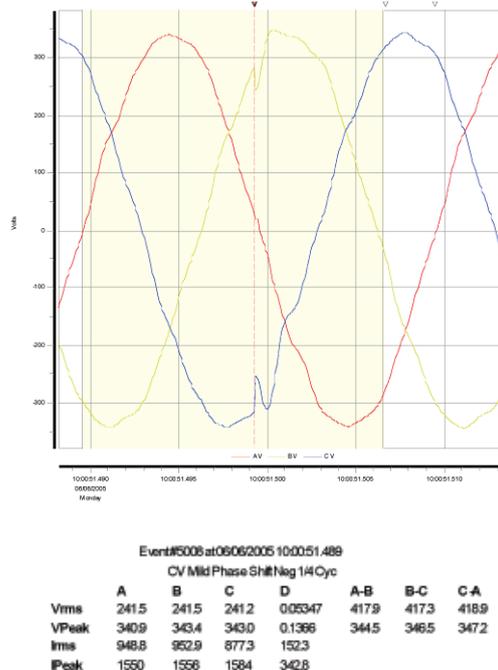
During the power quality logging period a failure of the conveyor system was logged at about 10am on the morning of June 6th 2005. Upon inspection of the data recorded it was apparent that a voltage transient occurred at the time of the conveyor system failure. This voltage transient is shown in Figure 1.

Figure 1: Profile of voltage total harmonic distortion captured during initial harmonic analysis period.

Further power quality recording and logging of conveyor system failures yielded the same pattern, i.e. a step change in reactive power coincident with transients occurring at the same time as system failures. As a result of this we recommended that the old power factor correction incorporating 50 kVAr steps switched with non-soft switching contactors was replaced with 25 kVAr steps incorporating soft switching.

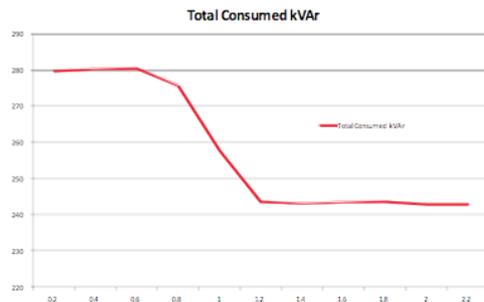
Figure 2 shows the reactive power consumption immediately before and after the transient event associated with the conveyor system failure. It can be seen that there is a step change (reduction) in the consumed reactive power at this time. This fall in reactive could mean either an inductive load being turned off (possibly a motor) or a bank of power factor correction capacitors being energised. As there was no appreciable drop in kW during this time it was felt most likely that a capacitor bank was responsible for the transient event recorded.

Figure 2: Reactive power consumed immediately before and after the transient event associated with the conveyor system failure
